The Performance of Kingspan Insurer
Certified PIR Core Sandwich Panels
in Real Fire Situations

Real Fire Case Studies

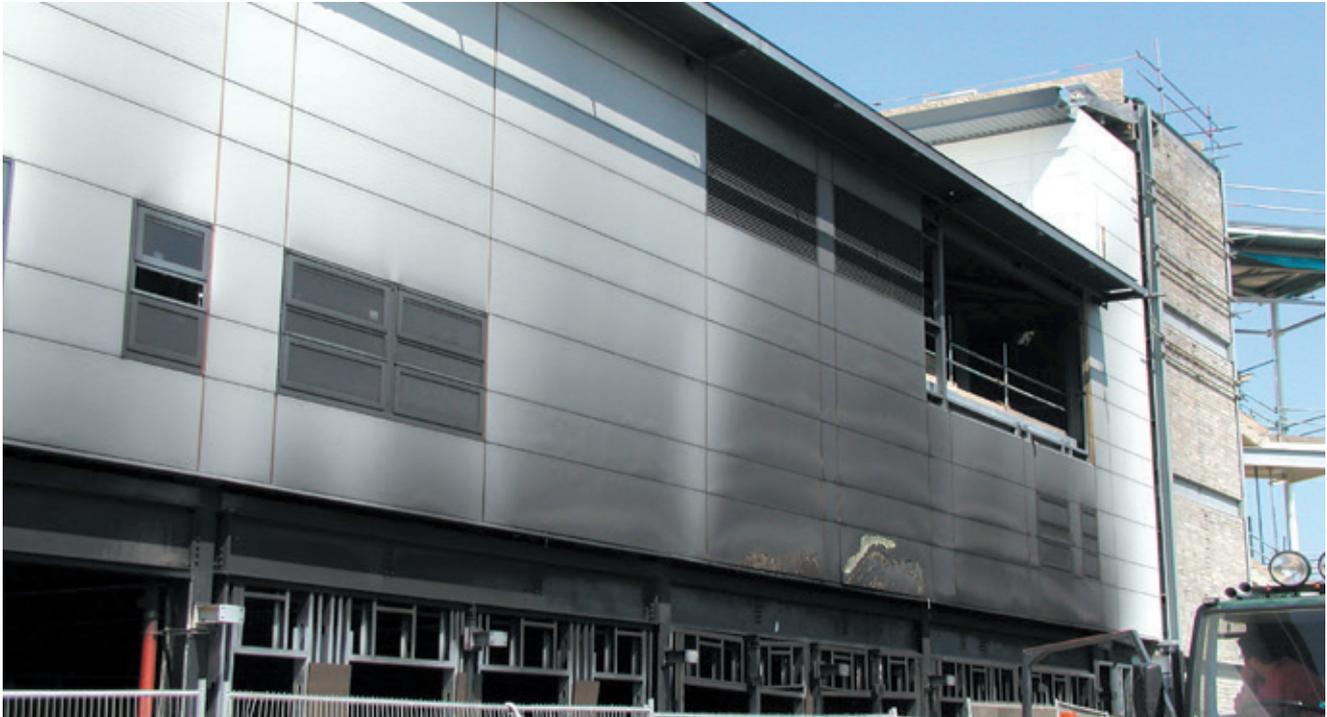
Photograph 1

It was thought that the fire was started deliberately by adhesive being poured over slabs of insulating material which were stored on the ground floor. *Photograph 1* shows the fire area.

The heat generated by the fire was significant, as evidenced by cracking of the concrete floor above the fire and the distortion of steel beams that had been protected by a fire resisting intumescent coating.

The fire service found light smoke but no fire spread on the upper floors of the building. They also reported that although the joint between the floor and first floor walls had not been fire stopped there was no fire spread within the PIR core material. *Photograph 2* shows where the flame damaged outer skin of the bottom panel has been lifted to inspect the slight charring of PIR core beneath.

The main image above shows where the insulated cladding panels on the external face of the building had been attacked by flames.

In spite of a very severe fire at ground level (sufficient to damage the concrete floors and distort fire protected steel beams) the cores of the insulated panels:

- did not ignite; and
- did not promote fire spread.

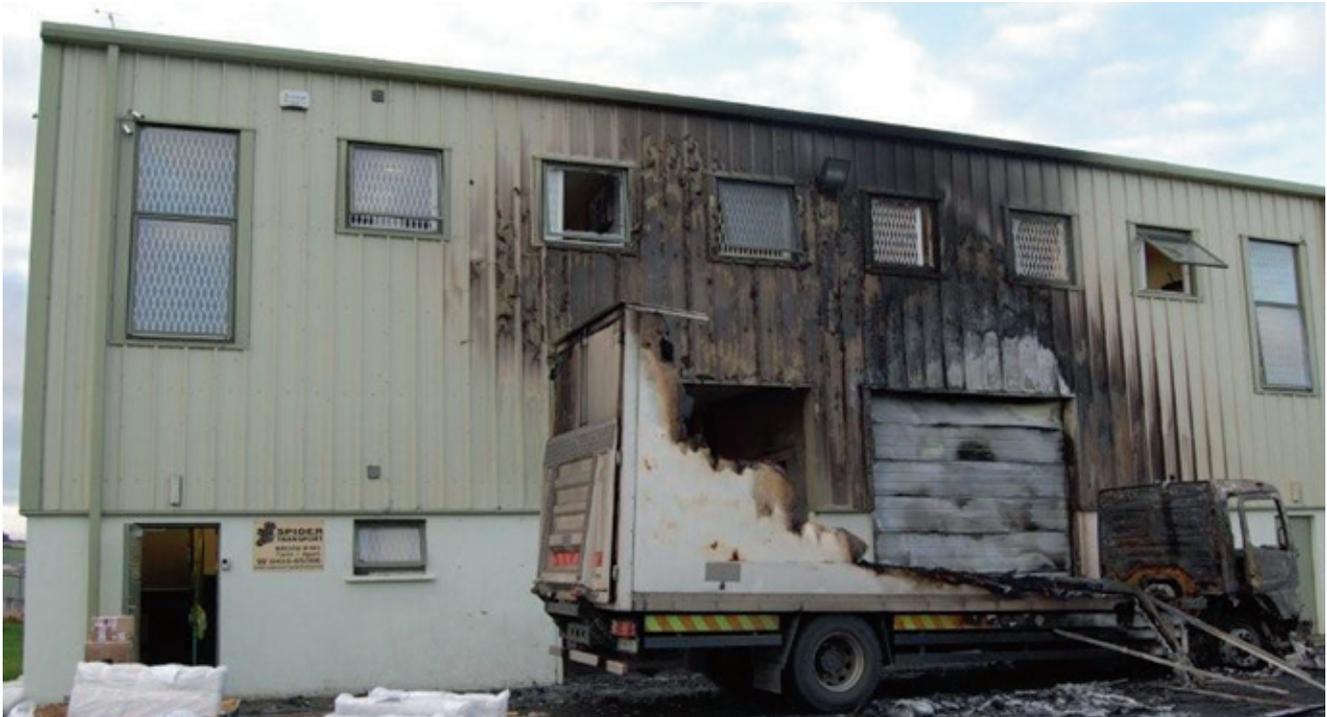
The main image above shows the aftermath of the fire. The upper parts of the external wall consisted of Kingspan Trapezoidal KS1000 RW insulated panels which complied with LPCB Grade EXT-B to LPS 1181 Part 1, whilst the lower parts were constructed of blockwork.

Although the bottom of the insulating core of the Kingspan insulated panels was directly exposed to flame impingement above the up and over door, there was no delamination of the skins of the panels and the insulation remained in place.

- The integrity of the Kingspan insulated panels was maintained, even immediately above the up and over door where the bottom of the insulating core was exposed to flame impingement and suffered severe charring.
- There were no signs of any spread of heat via the cores of the Kingspan insulated panels to any point within the building and no signs of spread within the cores of those panels.
- There is no indication that the Kingspan insulated panels contributed to the heat damage caused by the fire.

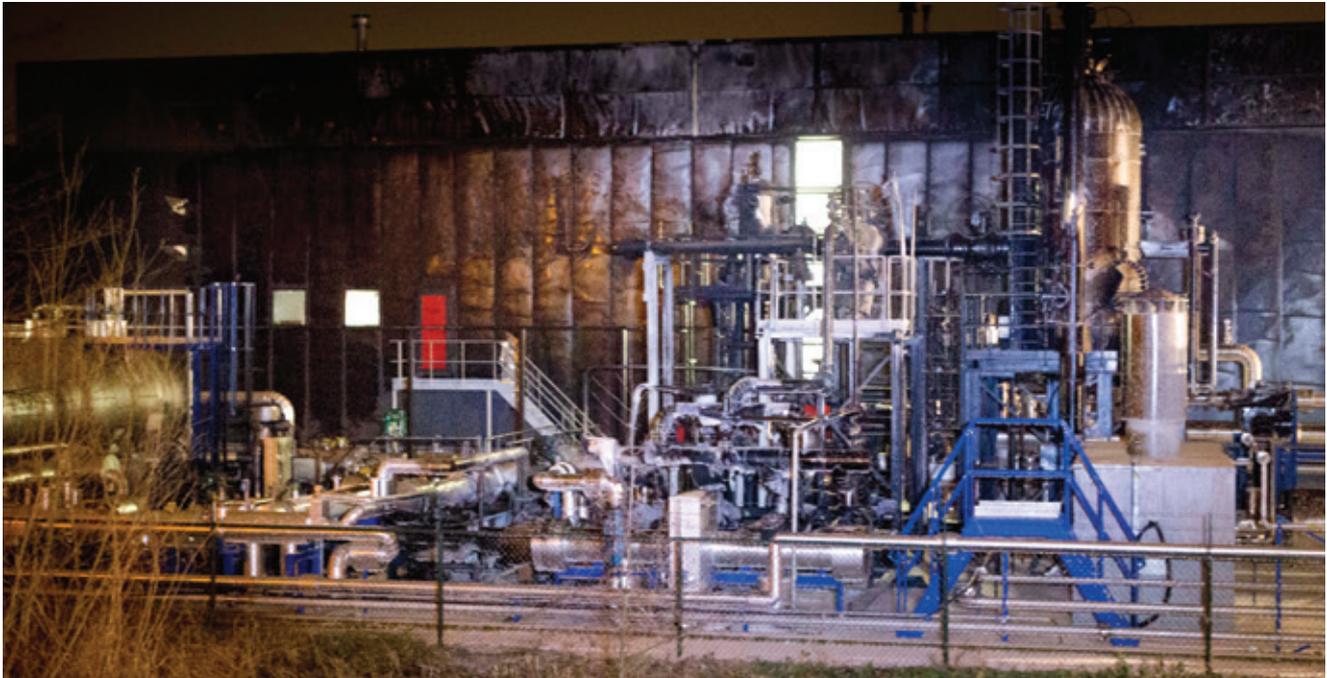
There appears to have been little or no direct flame impingement on the external cladding of the building. However, the building would have been subject to high levels of radiant heat flux from the fire plume and this has been estimated to be of the order of 24kW/m².

The intensity of radiation received by the panels caused some surface flaming but this ceased after approximately 30s (presumably after the surface coating had burned away). There was otherwise no evidence of self-sustaining flaming from the panel surface or at joints between panels.

As a result of the intensity of heat radiation the steel facing to the panels became rippled and delaminated from the foam core but there was only limited foam degradation at the core surface.

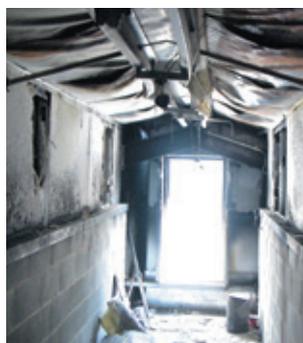
Photograph 1 shows the area where the fire started, in an enclosed passageway linking two open air plant areas on the roof. There was scaffolding at the rear of the premises which gave access to the roof and the fire was thought to have been caused by the accidental or malicious ignition of roof sealant.

Photograph 1 also shows the empty drum thought to have contained the roof sealant, and holes made in the partition system by the fire service to check that the fire had been completely extinguished. The plastic and glass components of the fire alarm and light fittings had shattered / melted and although delamination of the inner skin of the insulated panels occurred, the core and outer skin remained undistorted.

The deformation of the purlins immediately above the seat of the fire indicated that this was a very hot fire.

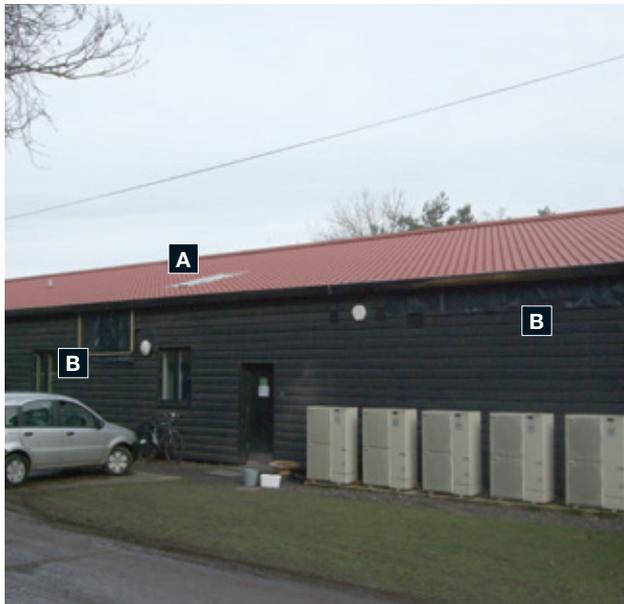
A: Vent cut in roof by fire service. **B:** Vents cut in wall by fire service.

On locating the area of the fire the attending fire service cut a hole through the roof construction directly above the fire and in the location of the damage shown in the above image to ventilate the area. The images show the hole which was cut (which has been temporarily re-covered). The effect of the heat of the fire on the PIR core can be seen showing delamination of the exposed steel skin of the sandwich panel from the core, the formation of a carbon char layer and unaffected material at greater depth in the section which has been insulated from the fire.

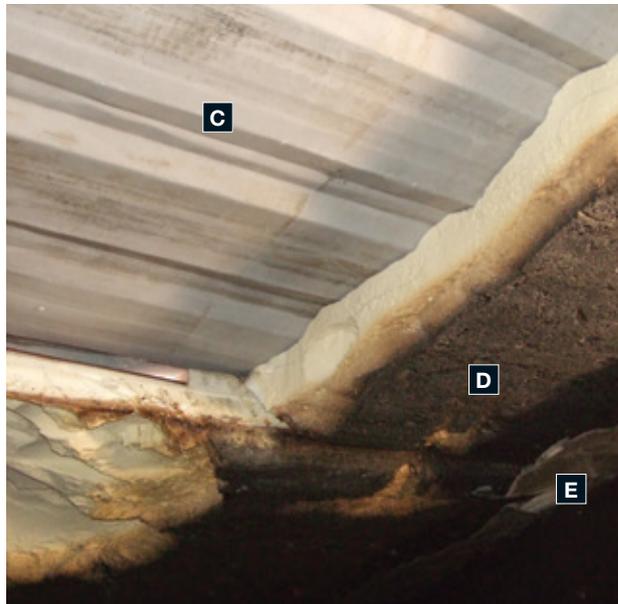
C: Temporary roof covering over hole in roof. **D:** PIR core showing delaminated lower surface and extent of through-thickness charring. **E:** Cut edge of lower steel skin of sandwich panel.

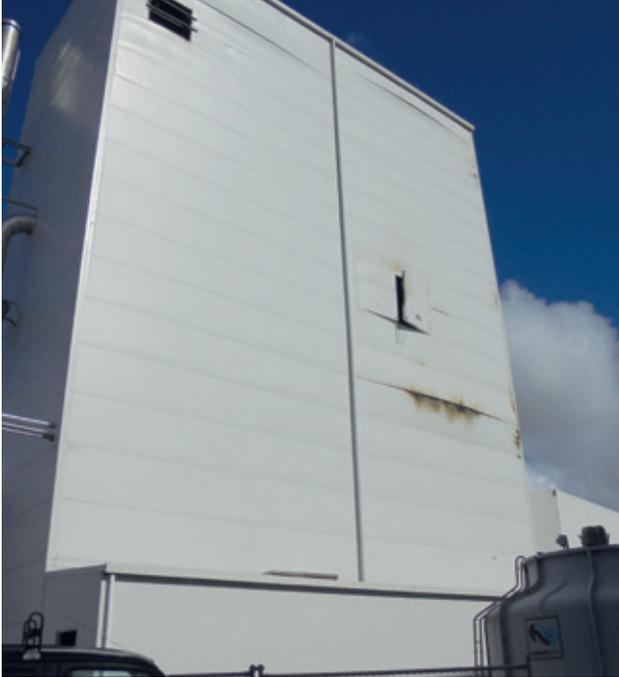
Milk powder drying tower showing external fire damage to panels (explosion doors opened manually after fire)

Findings concluded that a fire emanated in the region of the base of the milk powder drying cyclone and the fluid bed dryer. It is in this area, approximately mid-way up the tower, that there is extensive fire damage to the plant and structure and where the cladding had been exposed to direct flame impingement. Here the fire has penetrated into the PIR core causing the material to surface char.

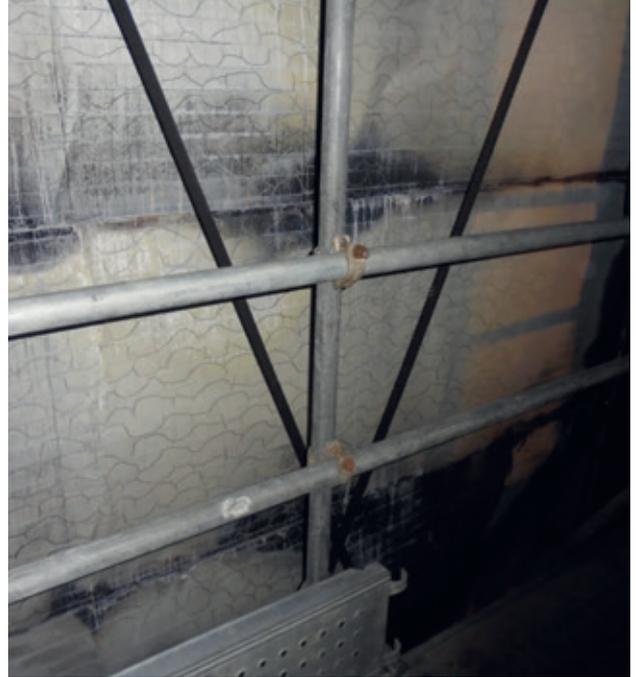
Panels exposed to fire internally

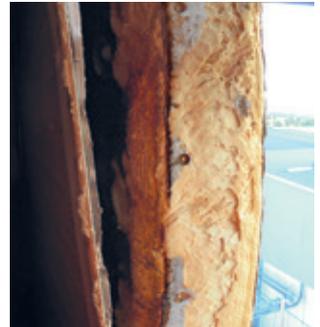
Window removed by Fire Service to ventilate the building to gain access – no fire penetration of core material

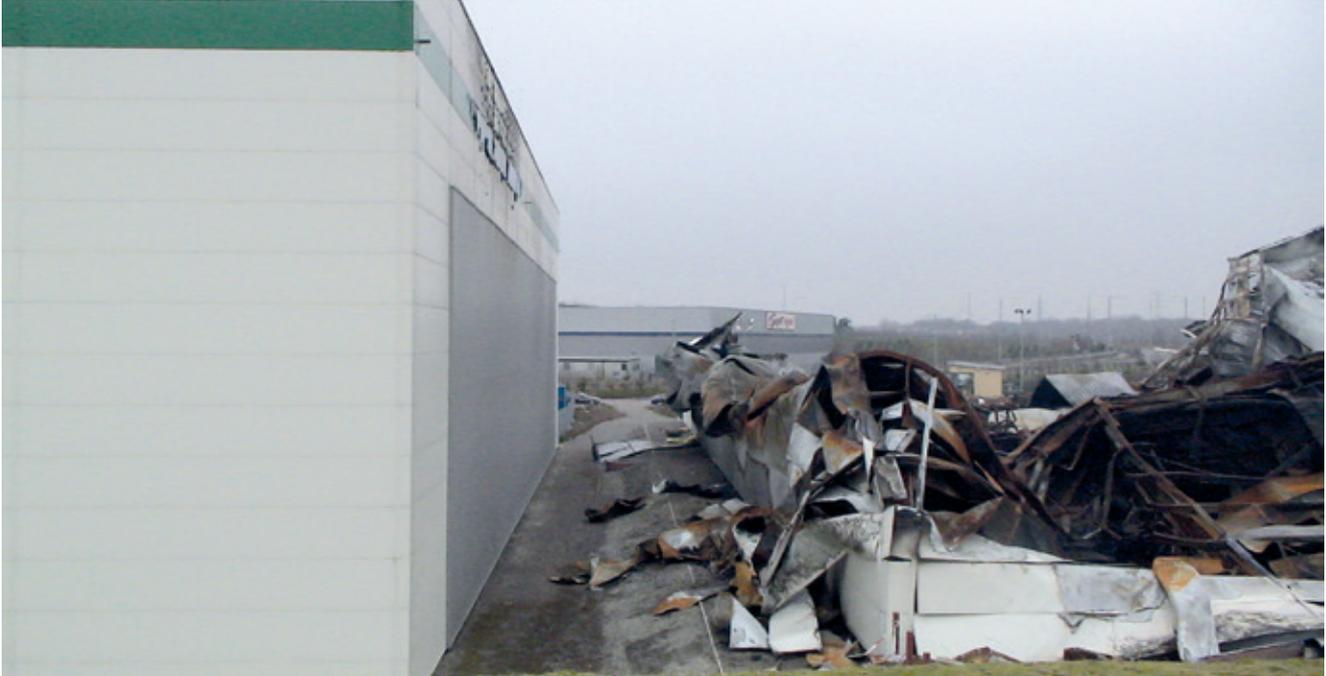
The main image above shows north elevation of the adjacent building following the fire. The insulated cores of the panels did not ignite and did not transfer heat damage to the interior of the building.

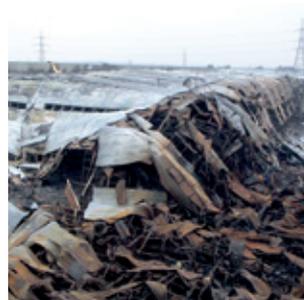
Collapsed south end of building.

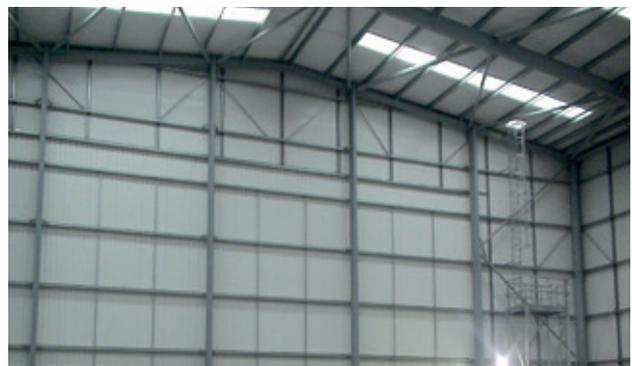
No heat transfer damage to interior of adjacent property.

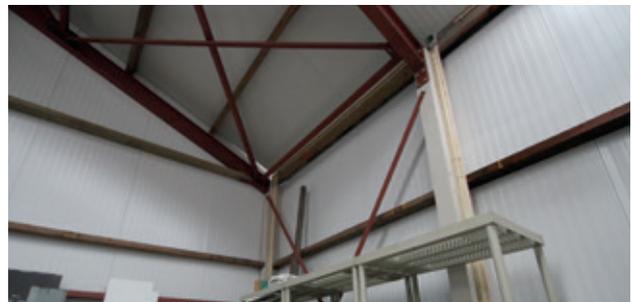
- The fire in building B would have subjected the external façade of building A to levels of radiative heat flux sufficient to cause delamination of the PIR panels and charring of the PIR core.

No heat transfer damage to interior of adjacent property (building A).

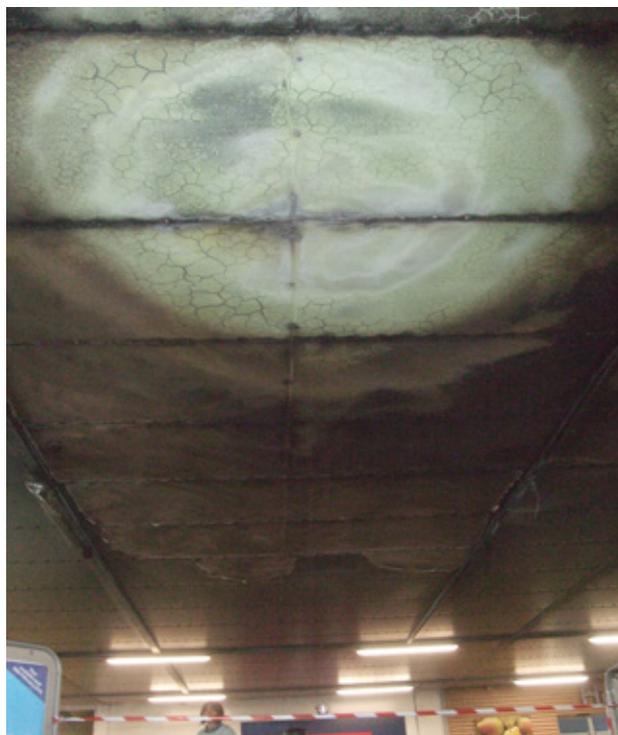
- The PIR cored sandwich panels were subject to a period of fire exposure lasting at least 8 minutes and resulting in a period of sustained flame impingement directly above the fire and gas temperatures to a distance away from the fire sufficient to destroy plastic light fittings.
- The sandwich panels exposed to these conditions sustained damage in terms of removal of the paint coating together with distortion and delamination of the exposed steel skin of the panels away from the PIR core.
- There was no evidence of joints between panels opening up and no PIR core material had been exposed.

Evidence of direct flame impingement on soffit lining directly above the car
