The Performance of Kingspan Insurer
Certified PIR Core Sandwich Panels
in Real Fire Situations

Real Fire Case Studies

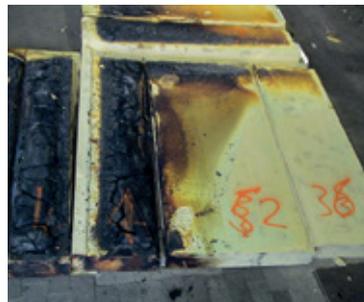
Panels at end of test with metal facings removed showing protective char formation on surface of insulation

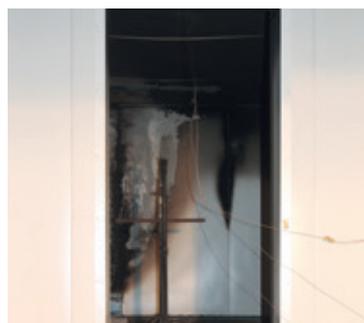
End of test showing limited internal damage and no evidence of flash-over conditions

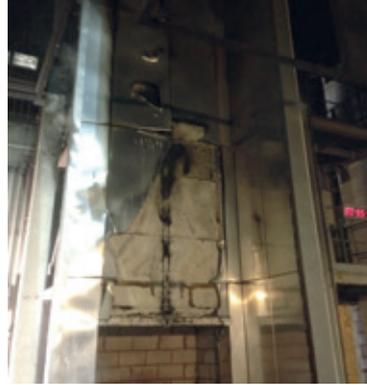
End of test showing aluminium panel melted away to expose underlying Kingspan BENCHMARK PIR core panel in place

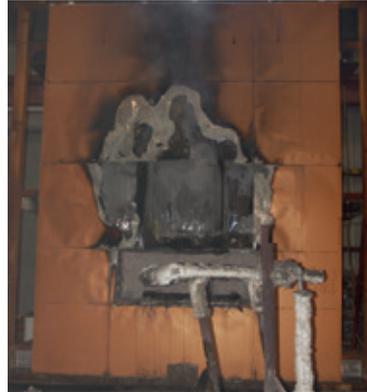
End of test demonstrating damage to ACM rainscreen with Kingspan insulated metal panels remaining intact

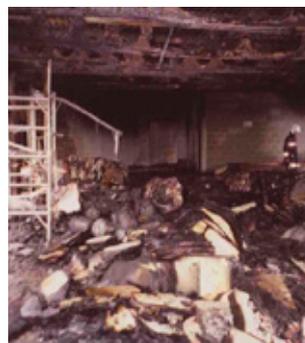
Photograph 1

It was thought that the fire was started deliberately by adhesive being poured over slabs of insulating material which were stored on the ground floor. *Photograph 1* shows the fire area.

The heat generated by the fire was significant, as evidenced by cracking of the concrete floor above the fire and the distortion of steel beams that had been protected by a fire resisting intumescent coating.

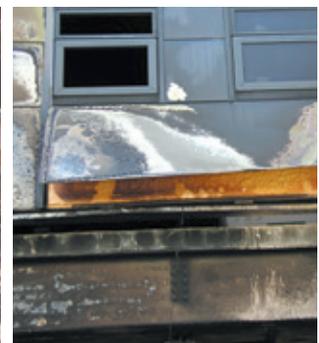
Photograph 2

The fire service found light smoke but no fire spread on the upper floors of the building. They also reported that although the joint between the floor and first floor walls had not been fire stopped there was no fire spread within the PIR core material. *Photograph 2* shows where the flame damaged outer skin of the bottom panel has been lifted to inspect the slight charring of PIR core beneath.

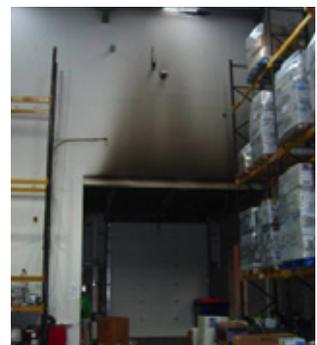
Photograph 2

Photograph 1 shows a CCTV image of the truck fire. *Photograph 2* shows that the fire did not get into the building.

- The integrity of the Kingspan insulated panels was maintained, even immediately above the up and over door where the bottom of the insulating core was exposed to flame impingement and suffered severe charring.
- There were no signs of any spread of heat via the cores of the Kingspan insulated panels to any point within the building and no signs of spread within the cores of those panels.
- There is no indication that the Kingspan insulated panels contributed to the heat damage caused by the fire.

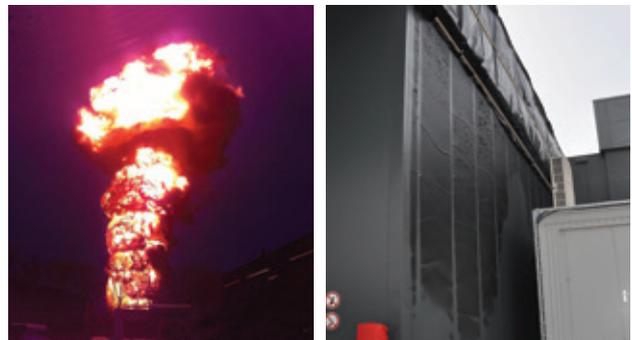
There appears to have been little or no direct flame impingement on the external cladding of the building. However, the building would have been subject to high levels of radiant heat flux from the fire plume and this has been estimated to be of the order of 24kW/m².

The intensity of radiation received by the panels caused some surface flaming but this ceased after approximately 30s (presumably after the surface coating had burned away). There was otherwise no evidence of self-sustaining flaming from the panel surface or at joints between panels.

As a result of the intensity of heat radiation the steel facing to the panels became rippled and delaminated from the foam core but there was only limited foam degradation at the core surface.

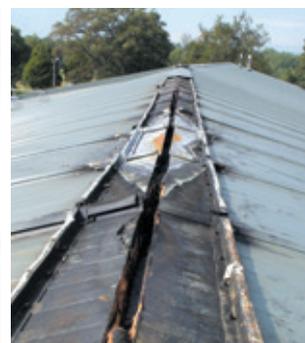
Photograph 2 shows the apex of the roof, with some discolouration in the area subject to direct flame attack, but no evidence of fire spread.

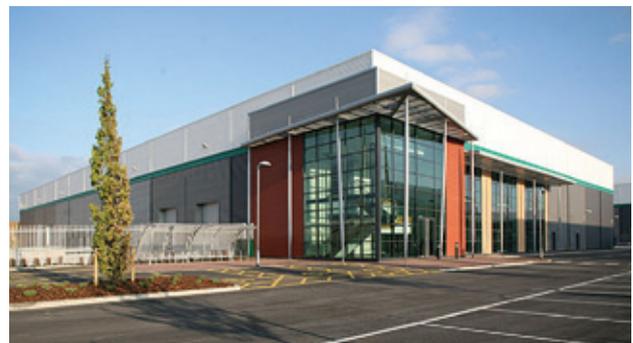
During their operations the fire service cut open the wall panels. This is standard practice to ensure that there is no continuing burning within the construction or voids. It was evident that where the fire service had opened up the panels there was only evidence of very limited charring of the PIR core with no suggestion of any fire propagation within the core material.

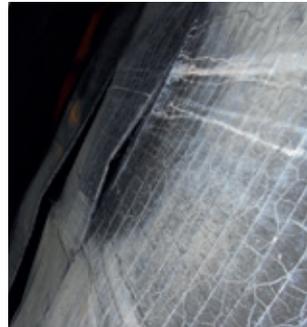
Fire penetration into panel core, material charred but still in place, no void

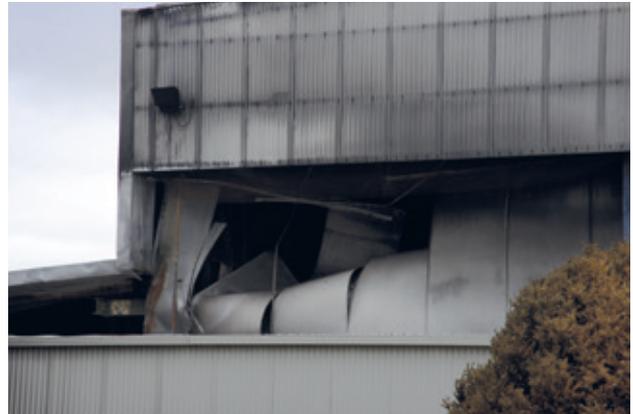
Photograph 1

The fire started at one end of the building in a storage area, and quickly spread through the building (*photograph 1*). The core material (EPS) in the wall panels has been destroyed by the fire, and the remaining panel steel faces have collapsed.

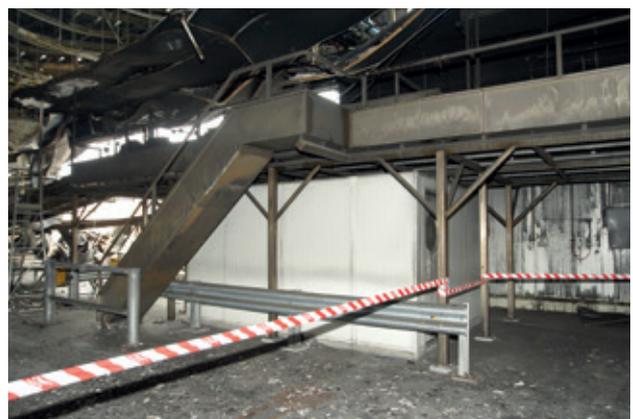
Photograph 3 shows a control room which still remains standing – built at the end of the building where the fire started, using Kingspan Insurer Certified PIR panels.

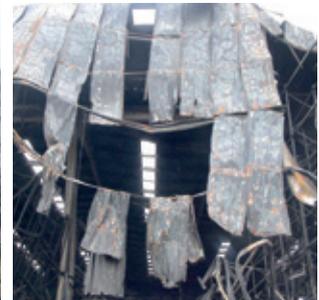
Roof sheeting hanging from severely deformed steelwork.

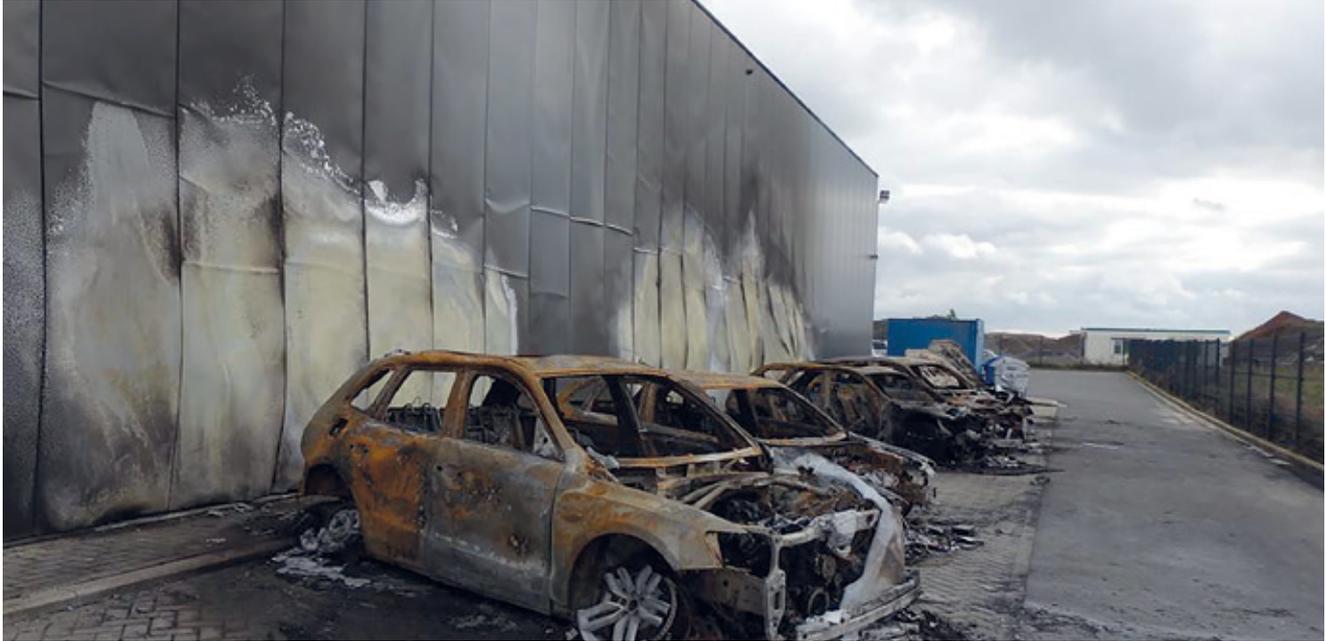
Photograph 1 shows the aftermath of the fire and is a photograph taken (by others) shortly after the fire event. The car in the foreground is understood to be an Audi Q3 with other cars being of at least a similar overall dimension and construction type.

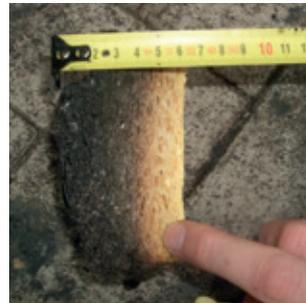
Photograph 2 shows a sample of the PIR core material removed from the cladding panel at the location of predicted peak incident radiative heat flux of 31.8kW/m^2 . The photograph indicates that the PIR core had pyrolysed to a carbon char to a depth of about 40mm at this location. At locations remote from the area of peak incident radiative heat flux, the charring of the PIR core was significantly reduced, demonstrating that combustion had not been propagated by the PIR core material.

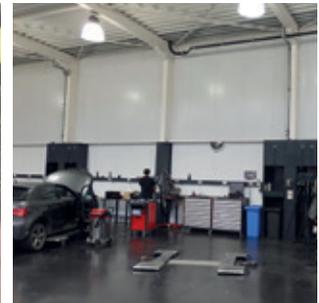
No evidence of fire penetration to interior of the workshop
